April 15, 2024

Pursuant to a fatal incident on March 8, 2024, Fluid Wings was informed that the GCAA and Skydive Dubai would ground all parachutes due to multiple line failures. Our engineer, Mr. Scott Roberts, MSCE, P.E., compiled a list of reported incidents and inspected the accident parachute and several other parachute lines.

AW 2 79-00043 - Investigated 4/5/24

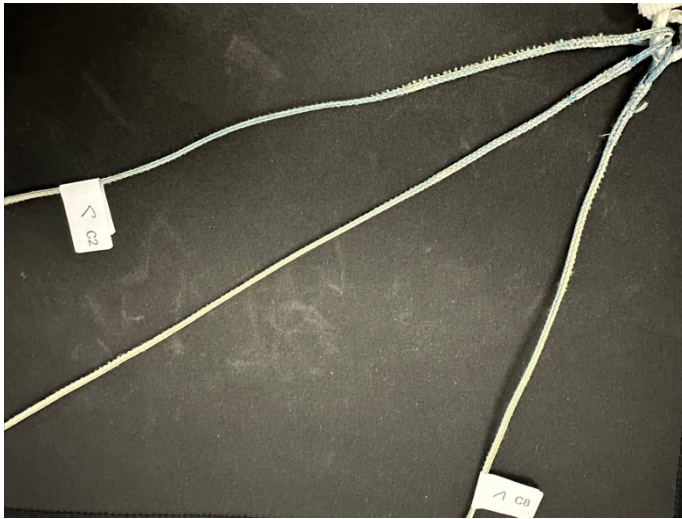
Photograph 1: Lower portions of lines.

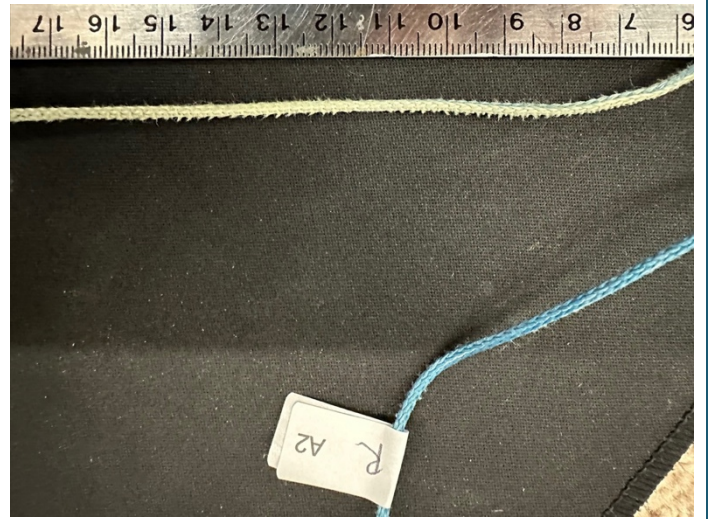
Photograph 2: Lower portions of lines.

Additional Comment(s) (If Applicable): Note severe abrasion and wear.

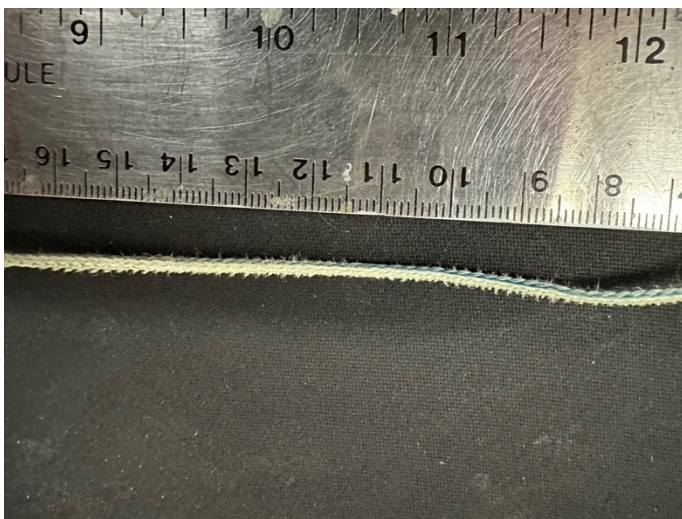
Photograph 3: Severe wear on lines.

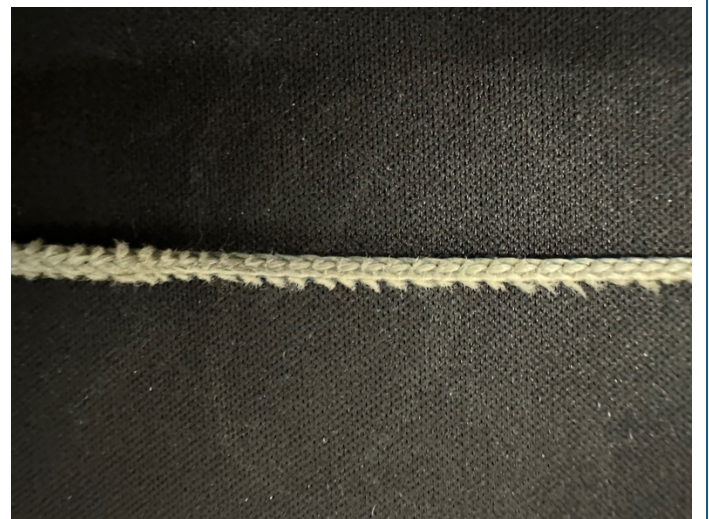
Photograph 4: Lower portions of lines.

Additional Comment(s) (If Applicable): Note severe abrasion and wear.

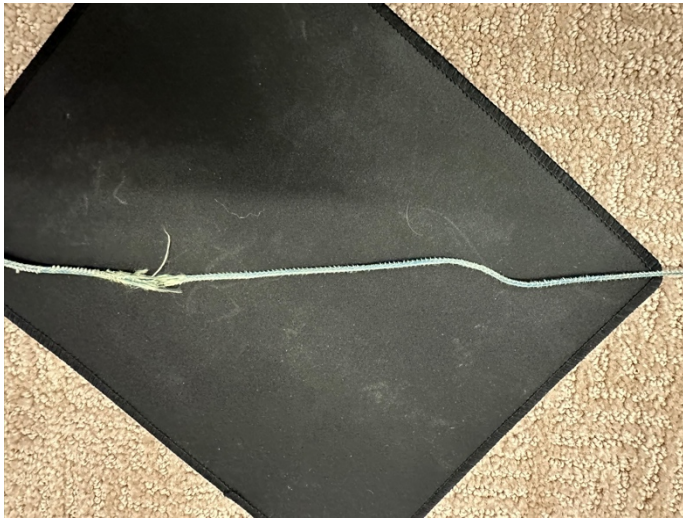
Photograph 5: View of broken line.

The evidence observed on the examination of the subject incident parachute (AIRWOLF2 79-00043) indicates that the condition of the lines would be considered severely worn and thus unairworthy. The severe wear is the result of prolonged use in a harsh environment.

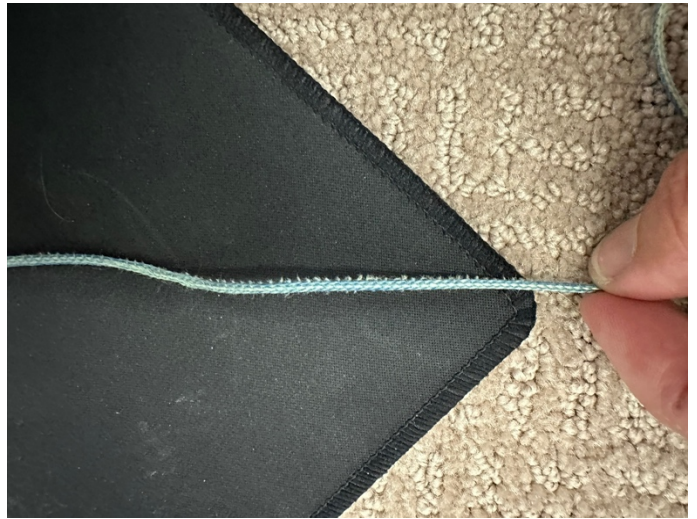
Photograph 6: Lower portions of lines.

Additional Comment(s) (If Applicable): Note severe abrasion and wear.

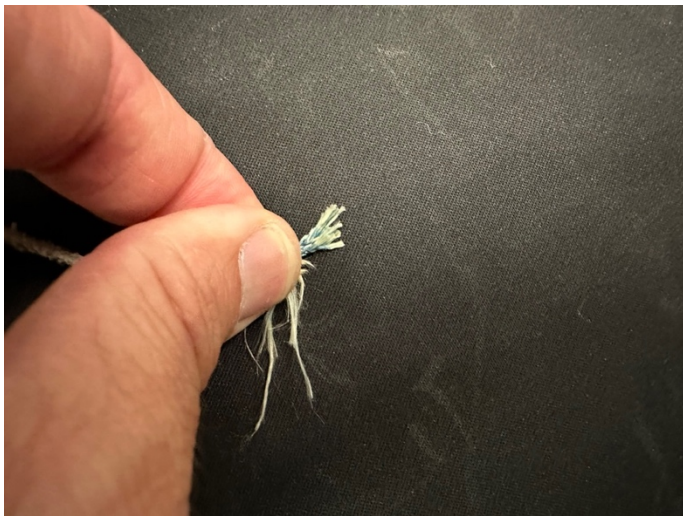
Photograph 7: View of angled cut at failed line.

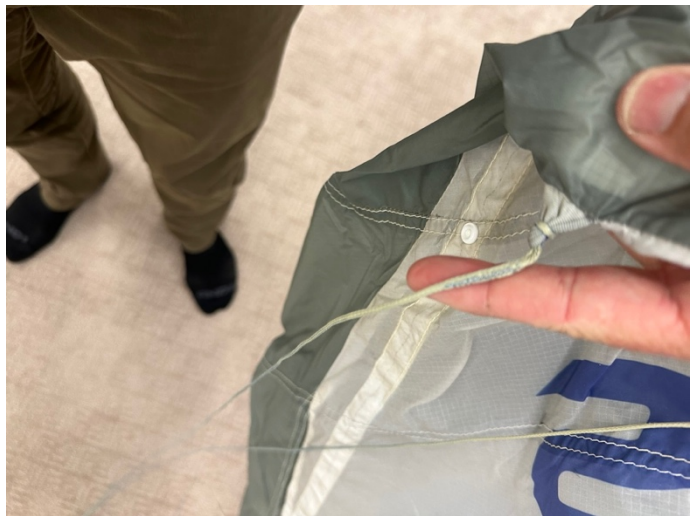
Photograph 8: View of wear at upper portion of lines.

Additional Comment(s) (If Applicable): Note severe abrasion and wear.

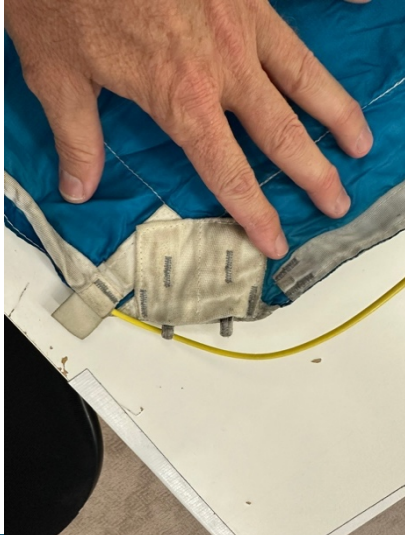
Photograph 9: View of dirt and debris on slider.

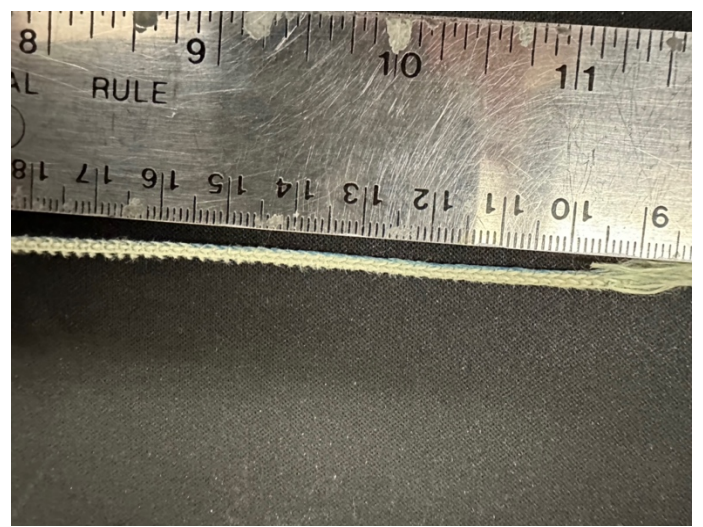
Photograph 10: View of wear on lower portion of line.

Additional Comment(s) (If Applicable): Note severe abrasion and wear.

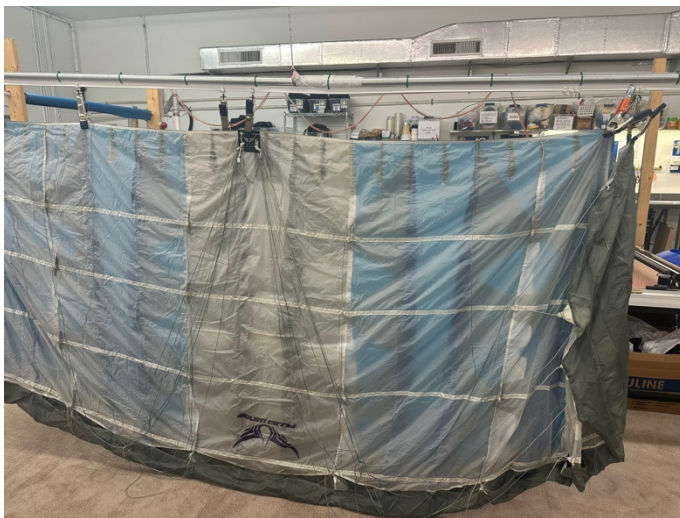
Photograph 11: View of parachute.

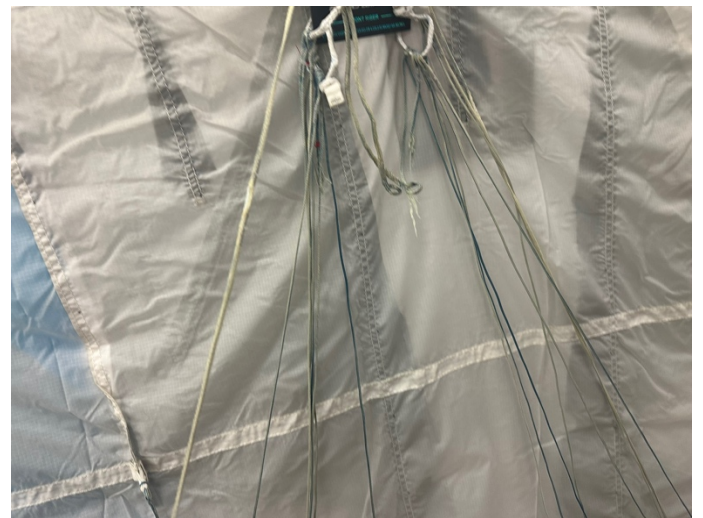
Photograph 12: View of lines on card as delivered.

Additional Comment(s) (If Applicable): Note severe abrasion and wear.

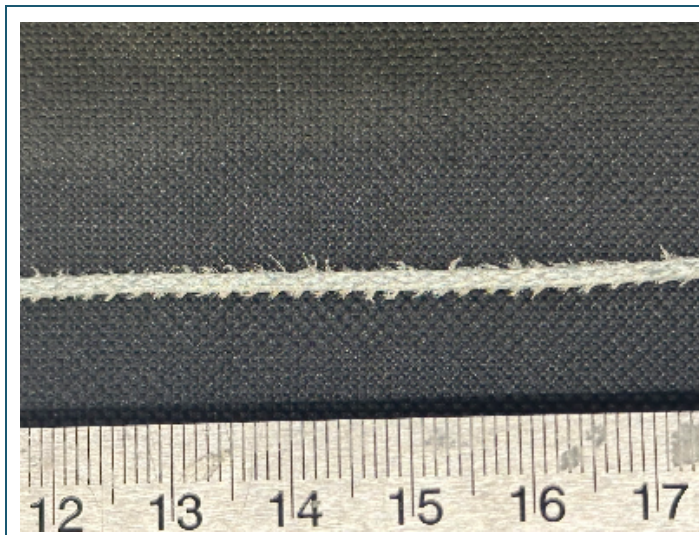
Photograph 13: View of wear on lines.

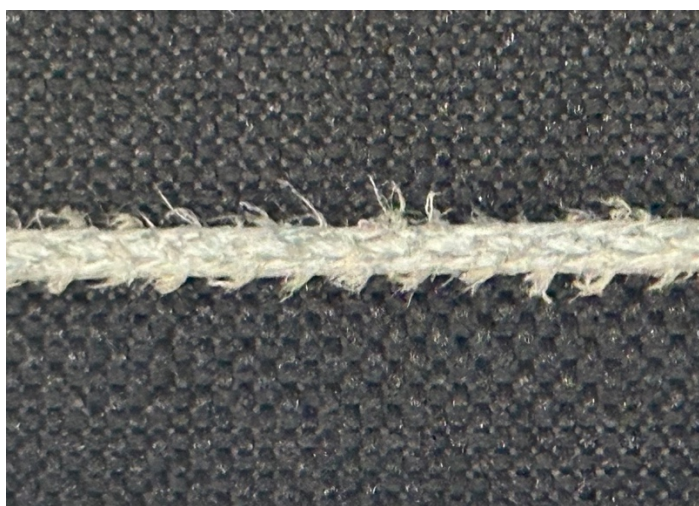
Photograph 14: Close up view of broken strands on the line.

Additional Comment(s) (If Applicable): Note severe abrasion broken strands and wear.

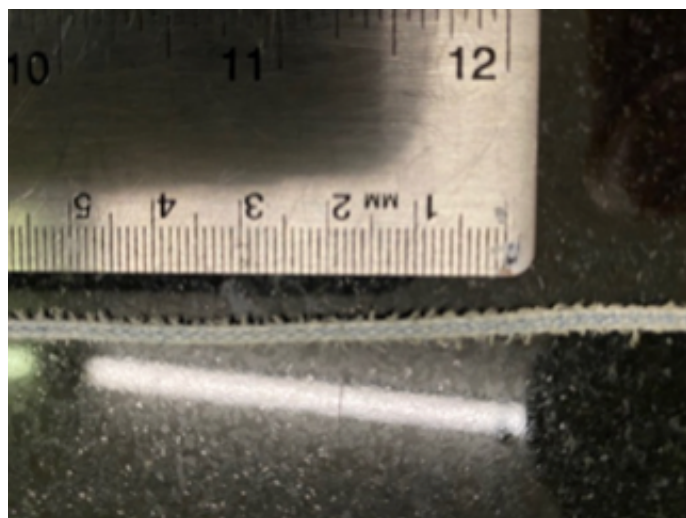
Photograph 15: View of wear on lines.

Additional Comment(s) (If Applicable): Note severe abrasion and wear on the left photo of the lines. Also note that the line set was deconstructed to verify that the cuts were made at angles.

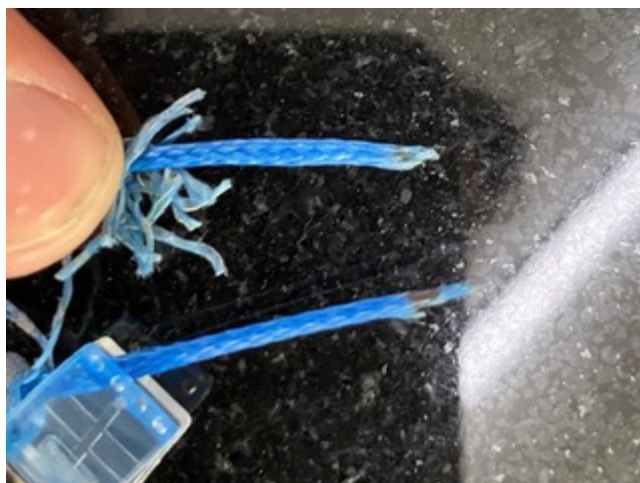
Photograph 16: View of line cut at angle on interior of splice.

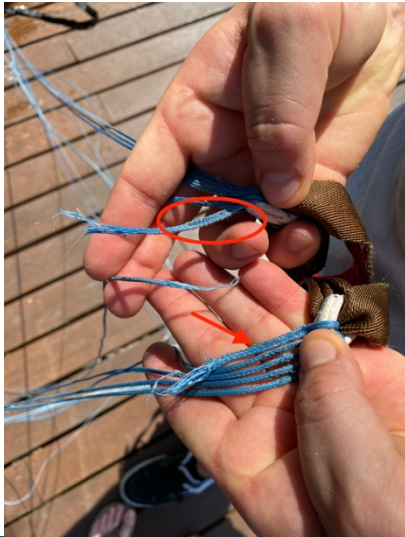
Photograph 17: View of wear on that jumper has included with several posts.

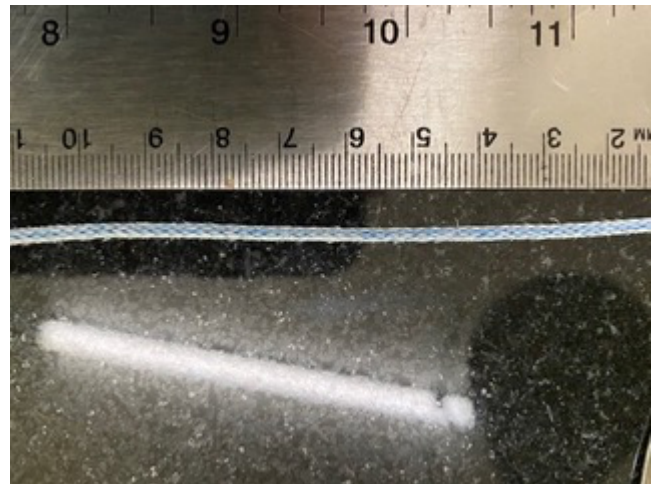
Photograph 18: View of line condition at upper portion of the lines.

Additional Comment(s) (If Applicable): Note wear in the lower portion of the lines at location of slider and condition at upper lines with less abrasion.
