April 15, 2024

Pursuant to a fatal incident on March 8, 2024, Fluid Wings was informed that the GCAA and Skydive Dubai would ground all parachutes due to multiple line failures. Our engineer, Mr. Scott Roberts, MSCE, P.E., compiled a list of reported incidents and inspected the accident parachute and several other parachute lines.

AW 2 79-00043 - Investigated 4/5/24

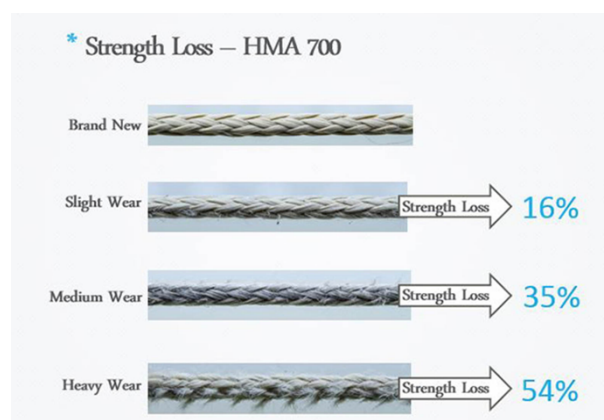
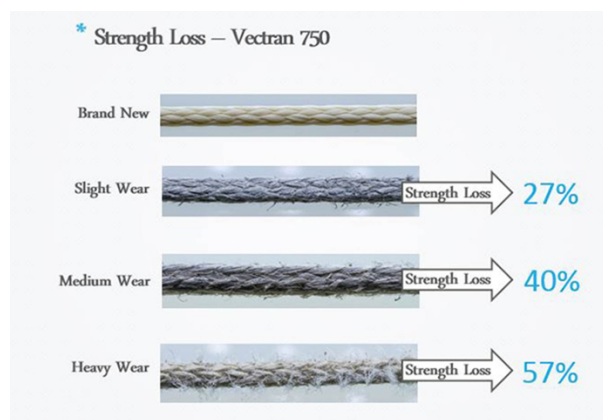
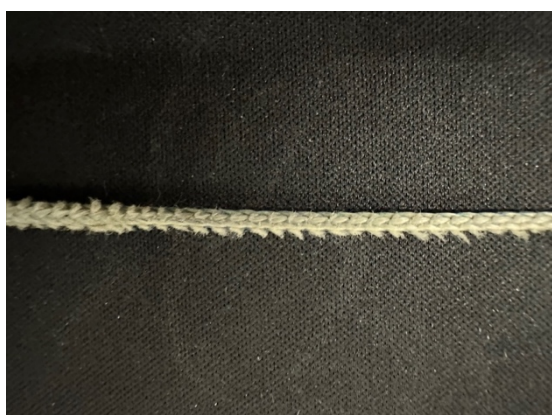
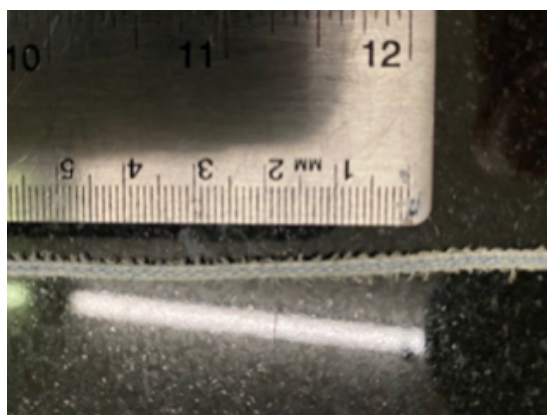
The following images are taken from: <https://parachutist.com/Article/Know-Your-Lines>

(Photographs previously noted in the observations section for reference purposes)

It should be noted that the wear conditions noted in the observed parachutes were generally worse than in the heavy wear category in the aforementioned article.

In areas with no visible wear, we noted tensile strength to be at approximately the nominal capacity. In the areas of the wing where maximum wear would be expected to occur (lower portion of the lines where the slider is rapidly flapping), the lines were in the range of 56% of their original capacity as taken by the average of the splices testing values on the spool that line set was manufactured from. The line tensile strengths on the lower portion of the parachute were severely compromised by long-term visible wear.

The subject parachute lines exhibited visible wear in a manner that the tensile capacity could reasonably be expected to be significantly reduced based on previously mentioned publicly available line wear information. Furthermore, the noted failure is consistent with failure patterns described in published literature. Therefore, we may conclude that the lines did not fail in an abnormal manner when their wear state is taken into consideration.
